Williams , S. R. and Wu, J. J. and Unsworth, A. and Khan, I. (2009) 'Tribological and surface analysis of 38mm alumina-as-cast Co-Cr-Mo total hip arthroplasties.', Proceedings of the Institution of Mechanical Engineers, part H : journal of engineering in medicine., 223 (8). pp. 941-954.

Abstract: There is currently much discussion over the use of ceramic femoral components against metal acetabular cups, for use in total hip arthroplasty. The current study investigates six hot isostatically pressed alumina femoral heads of 38 mm diameter articulating against six as-cast Co–Cr–Mo metallic acetabular cups. Standard walking-cycle simulator wear testing was carried out to 5×10^6 cycles using the Durham Mark II hip wear simulator, and wear was determined gravimetrically. In addition, surface topography, using a non-contacting profilometer, an atomic force microscope, and an optical microscope, was monitored throughout the wear test. The wear of the ceramic heads was found to be undetectable using the current gravimetric method; however, a change in the surface topography was seen, as grain removal on the pole was observed through atomic force microscopy analysis. A biphasic wear pattern

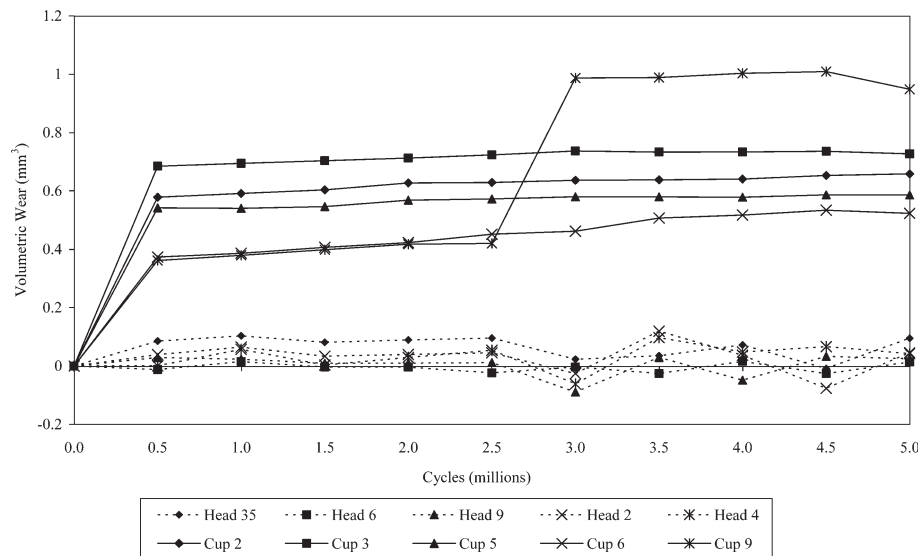
Fig. 1 Individual wear volume change of 38 mm alumina heads against as-cast Co–Cr–Mo cups worn to 5×10^6 cycles (incorporating loaded control) on a standard walking-cycle simulator

The volume change for the individual Co–Cr–Mo cups and alumina heads is summarized in Fig. 1. The volume losses and standard deviations for the heads were lower than the cups with greater variation in wear rates between the metal samples likely to be due to the differences in cup RI wear rates between 0 cycles and 0.5×10^6 cycles. The overall RI wear rate of $1.04 \pm 0.293 \text{ mm}^3/10^6$ cycles (mean, ± 95 per cent confidence interval) was measured; however, the heads experienced a gravimetrically non-detectable change in wear throughout the 5×10^6 cycle test. After the initial higher wear rate experienced by the cups a wear rate of $0.0209 \pm 0.004 \text{ mm}^3/10^6$ cycles (mean, ± 95 per cent confidence interval) was seen from 0.5×10^6 cycles to 5×10^6 cycles. The greater wear seen by cup 9 at 3×10^6 cycles arose because the joint ran dry, after which the joint returned to the lower wear rate.

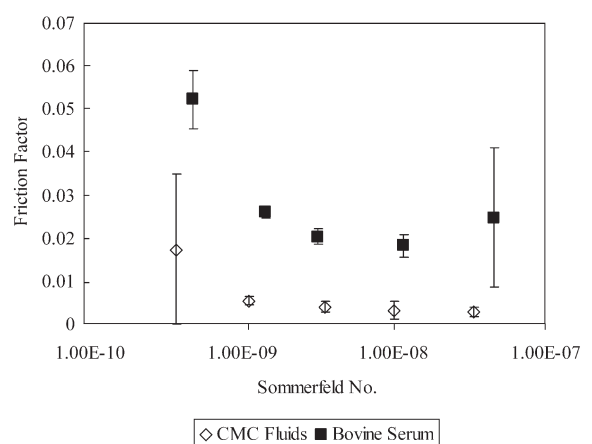
Fig. 2 Stribeck plot for a 38 mm alumina head against Co–Cr–Mo alloy cup worn to 5×10^6 cycles in a standard walking-cycle simulator

Figure 2 shows a typical Stribeck plot of an alumina head against a Co–Cr–Mo cup worn to 5×10^6 cycles in a standard wear simulator. The joint was lubricated in a range of viscosities of both CMC fluid and BS with the addition of CMC fluid. After 5×10^6 cycles of wear testing, the friction factor of the prostheses when lubricated in BS was found to be higher than when lubricated in CMC fluids. A distinct difference could be seen between the friction factors resulting from lubrication with the two different fluids. The friction factor in 25 per cent BS was 0.052 and with distilled water was 0.017. The shape of the curves, in addition to the friction fac-

tors, indicate that the joint is working close to full fluid-film lubrication in parts of the walking cycle.

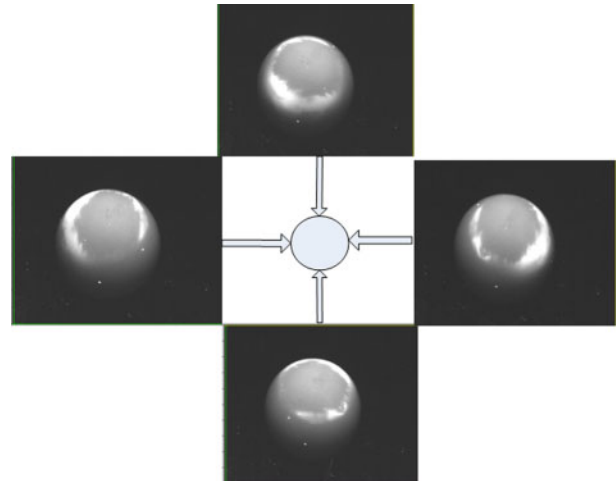
Fig. 3 UV images of deposition on a 38 mm alumina head after 0.5×10^6 cycles of wear testing in a standard walking-cycle simulator

Analysis of the bearing surfaces during wear simulator testing revealed a white deposit on both components, as shown in Figs 3 and 4. The deposit on the ceramic heads was difficult to see by eye and therefore was visualized using a UV light and a CCD camera. The deposit was clearly visible on the metallic cups and therefore was recorded using a digital camera. The deposit was situated on the pole of the head, leaving a clear circular contact area where no deposit was present. Many abrasive scratches protruded into the deposit, revealing the underlying ceramic material. There was no evidence of deposited material on the surface of the loaded control sample.

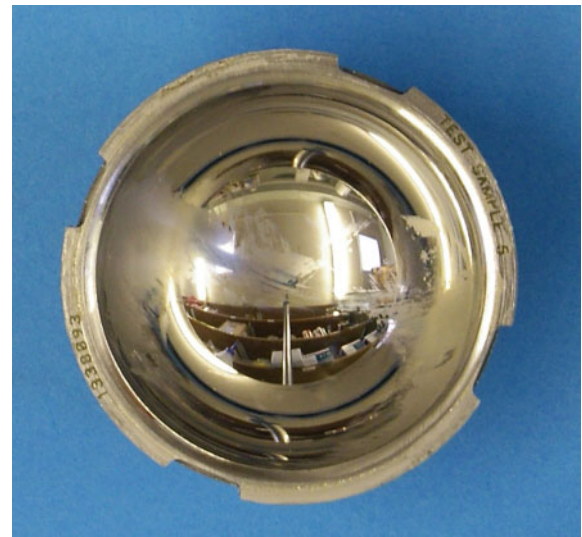
Fig. 4 Digital image of the deposit left on the Co-Cr-Mo alloy cup after 0.5×10^6 cycles of wear testing in a standard walking-cycle simulator

In the current study, a white deposit was also noticed on both the ceramic head and the metallic cup. Digital images were taken of the cups, in which the deposit can be seen in the superior quadrant of all cups, with the exception of the control, where no deposition was found. The wear patch can clearly be

seen in the centre, where contact has occurred and no deposit is observed. Scratches protrude into the deposit, showing that abrasive wear was occurring; however, these scratches are not noticeable on the underlying metallic surface. The deposit was located on the top of the ceramic heads in a u-shaped pattern which was evident on all heads except the control. As with the cups, scratches were visible in the deposit but not the actual ceramic surface. The area with no deposition on the cup corresponded to the area on the head and was therefore expected to be the wear patch. On the cups, the wear patch was evident owing to visible carbide pull-out and abrasive wear. This can be seen from the optical images of the cup where the carbide and matrix material was pulled out, and corresponding scratching of the matrix material is obvious (Fig. 7(a)). It could be concluded that third-body particles may have caused the damage, as these are possibly due to carbides or alumina grains removed from the femoral heads. The scratches seen were continuous over the harder carbide components within the matrix; therefore a material of similar or greater hardness is likely to have caused the damage. The parallel regular scratches in the pole indicated that wear was due to repetitive movement during simulation, which was not present outside the wear patch (Figs 7(a) and (b)).

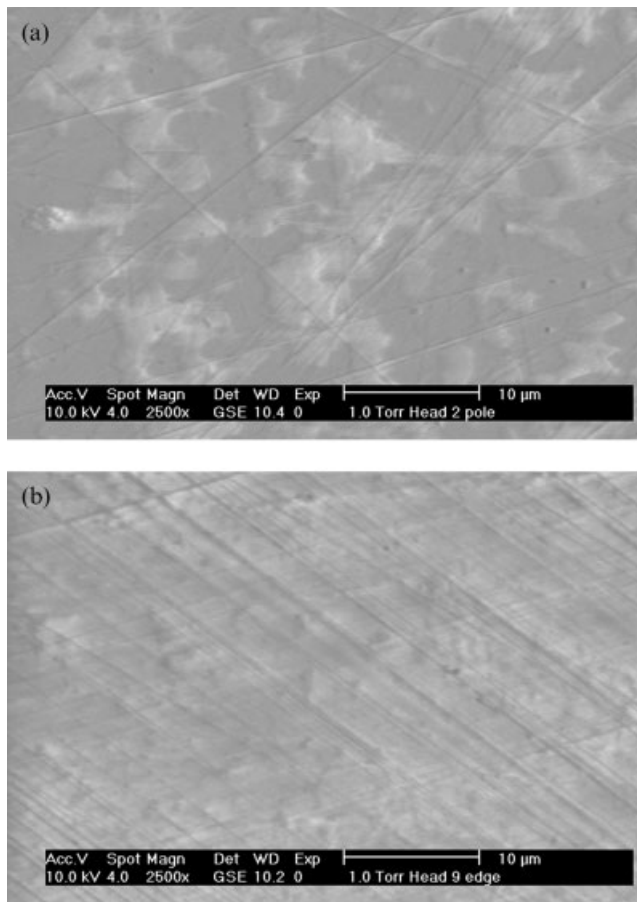
Fig. 5 Typical ESEM images of the alumina head (a) in the wear track and (b) out of the wear track

Surface analysis of the ceramic heads using a white-light profilometer showed minimal wear or surfaces changes. Small quantities of metal transfer could be seen on the heads, the majority deposited outside the contact area, which is a result of setting up the simulator. Analysis showed the transfer to be nanometres thick. ESEM analysis of the heads revealed visible grains in the centre of the wear patch with occasional grain removal (Fig. 5(a)). Faint multi-directional scratches were also visible. Regular directional scratching was seen outside the wear patch; however, the grains were much less obvious unless a single grain or cluster of grains had been pulled out (Fig. 5(b)).

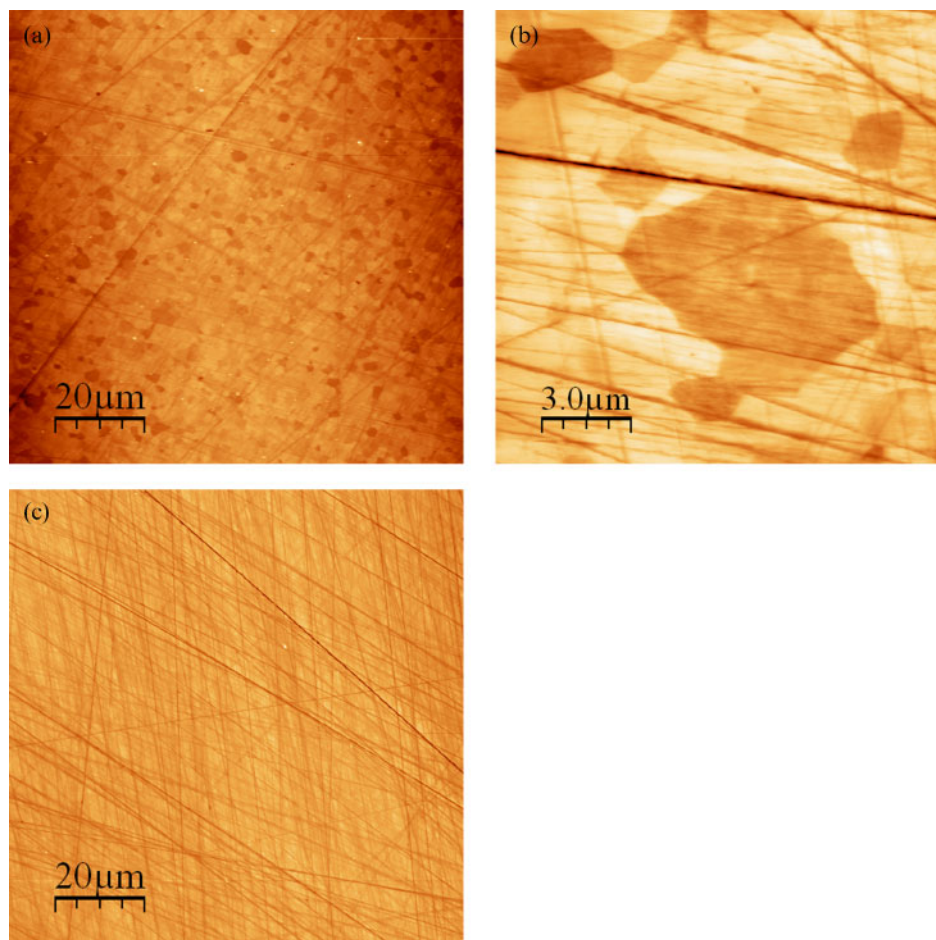
Fig. 6 AFM image of a ceramic head (a) in the wear track (pole) showing individual grain removal, (b) at a greater magnification in the wear track (pole) showing individual grain removal and abrasive scratches, and (c) in an unworn area of the head

atomic force microscope. Micrographs were taken in the wear patch on the pole of the head. Figure 6(a) shows a $100 \mu\text{m}$ scan of the surface on the pole in which pulled-out grains appear to be to $5 \mu\text{m}$ in size. Figure 6(b), which is at a higher magnification,

confirms this and clearly shows abrasive scratches. The grains were clearly visible on the pole of all heads but generally not away from the wear track. Images of the loaded control head and unworn areas of the worn components revealed multi-directional polishing scratches, where grains were not visible and grain pull-out was not observed. This is illustrated in Fig. 6(c).

For the ceramic femoral heads, no noticeable changes in surface roughness were found throughout the tests, indicating little wear. Although ESEM and AFM images showed occasional grain pull-out in the wear track (e.g. Figs 6(a) and (b)), there was no macroscopic damage on any worn head. Grains were visible on the wear patch but, outside the wear patch, multi-directional polishing marks resulting from manufacture were observed (Fig. 6(c)). Changes in the surface topography were found. The peak-to-valley value of the cups was greatest at 2×10^6 cycles (Fig. 9). This may be due to carbide pull-out during the first stages of the wear testing. A small decrease between 3×10^6 cycles and 5×10^6 cycles was probably caused by polishing of the metal cup by the harder ceramic head. Conversely the ceramic heads were found to have their greatest peak-to-valley value at 5×10^6 cycles, possibly owing

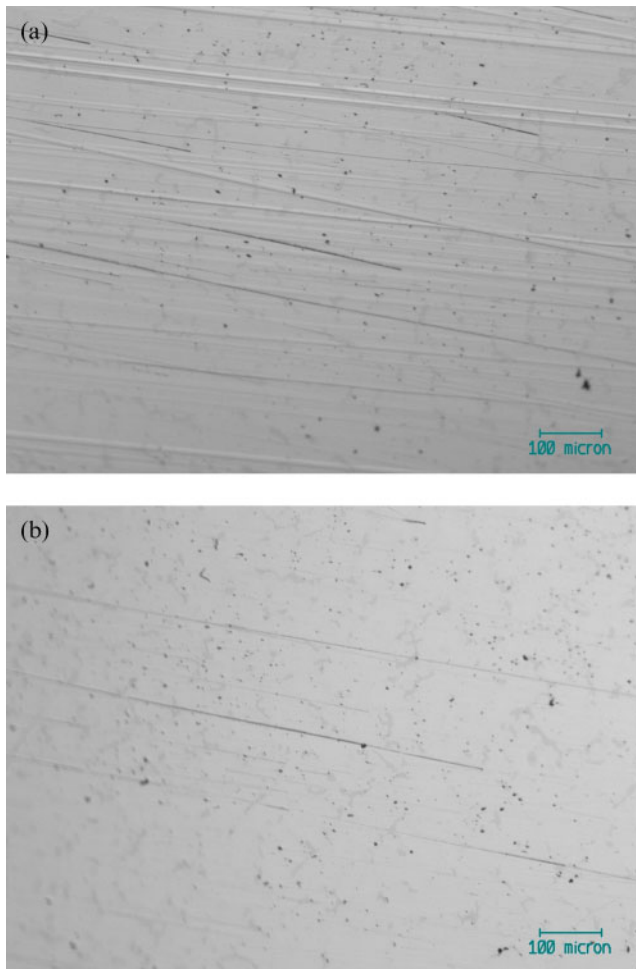
Fig. 7 Optical image of a Co-Cr-Mo alloy in the wear track after 5×10^6 cycles in a standard walking-cycle simulator showing (a) abrasive wear where the carbides in the matrix can be seen faintly and (b) pitting of the matrix and abrasive wear where the flattened carbides can be seen faintly

Pitting, carbide pull-out, and matrix removal were progressively seen in the metallic cups throughout the wear testing, with increased amount of scratches seen in the wear track. The width of the scratches appeared to be similar in size to the pits formed during material pull-out. By contrast, images taken out of the wear patch remained constant throughout the test.

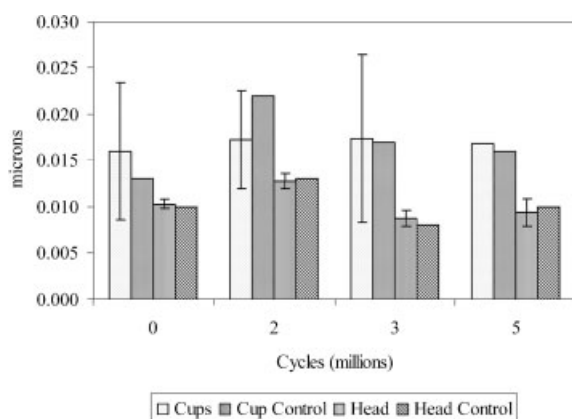
Fig. 8 Average change in r.m.s. roughness with number of cycles of the 38 mm alumina against Co-Cr-Mo alloy joints worn in a standard walking-cycle simulator

The average r.m.s. roughness (Fig. 8) of the ceramic heads at 0 cycles was $0.010\text{ }\mu\text{m}$, which was almost invariant throughout the wear test. Similarly, the r.m.s. roughness for the cups maintained a relatively

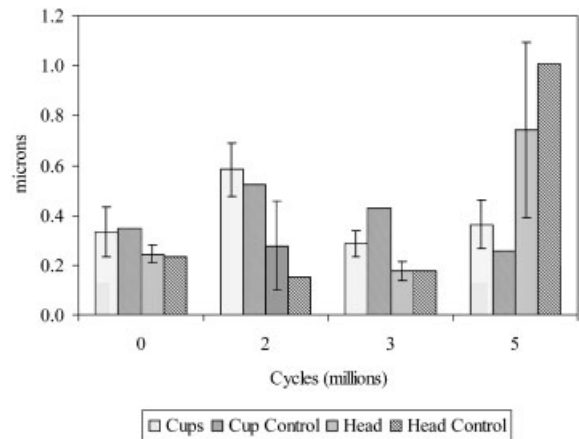
Fig. 9 Average change in peak-to-valley height with number of cycles of the 38 mm alumina against Co-Cr-Mo alloy joints worn in a standard walking-cycle simulator

to grain pull-out in the wear track. As polishing is less likely to occur on the ceramics, the holes left by pulled-out grains would remain at the original depth, therefore resulting in a large peak-to-valley value. However, it must be noted that small defects on the surface can lead to artificially large peak-to-valley values; the peak-to-valley value is not an average of the surface, but the largest distance between the highest and lowest points within the examination area. A low surface roughness with a large peak-to-valley value can indicate an individual feature on the head, rather than the large peak-to-valley value representing the dominant surface feature. The skewness values were as expected, with initially both head and cup showing skewness values close to zero (Fig. 10), indicating that the surface is equally as likely to have asperities above and below the mean line. However, as the test progressed, the skewness values for the metallic cups became more negative, indicating deep troughs compared with shallow peaks. This is consistent with the proposal that carbides are pulled out of the surface during wear testing. The ceramic heads produced low skewness values throughout testing until 5×10^6 cycles, where the worn heads became largely negatively skewed. This is consistent with the increase in the peak-to-valley value, and the observation of some grain pull-out, causing an increased change in the surface topography generally below the mean line. The standard deviation of the skewness of the worn heads at 5×10^6 cycles is large, and some heads had positive skewnesses. The result for the control at 5×10^6 cycles is surprising.

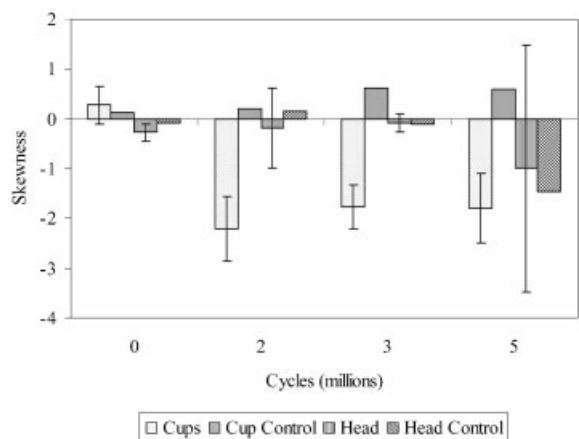
Fig. 10 Average change in skewness with number of cycles of 38 mm alumina against metal joints worn in a standard walking-cycle simulator

The cups initially had a positive skewness value (Fig. 10); conversely the heads had a negative skewness. As the test progressed the skewness of the worn cup became consistently negative; however, the control cup remained positive. The head skewness did not change much until 5×10^6 cycles whereas both the control and the worn heads became noticeably negatively skewed, which indicates deeper valleys than peaks.
